**ARIZONA DEPARTMENT OF ENVIRONMENTAL QUALITY  
HAZARDOUS WASTE INSPECTIONS AND COMPLIANCE UNIT**

**HAZARDOUS WASTE INSPECTION REPORT**

**FACILITY NAME:** Semiray Special Processes Division

**INSPECTION DATE:** February 1, 2010

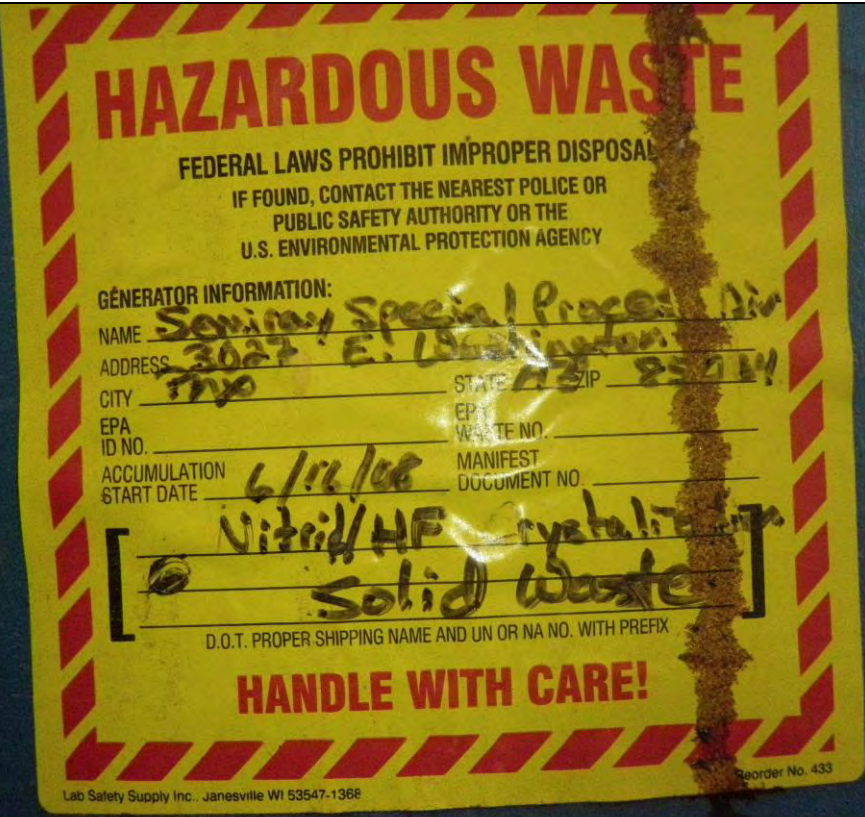
<b>Photographer:</b> Aleksandra Argals	
<b>Photo No.</b> 7	<b>Date:</b> 2/1/10
<b>Direction Photo Taken:</b> Close Up	
<b>Photo Description:</b>  180-Day Hazardous Waste Storage Area:  One 55-gallon Container marked "Hazardous Waste Nitric/HF Crystallization." The container was closed and was properly marked, but was generated more than 180 days from the date of the inspection.

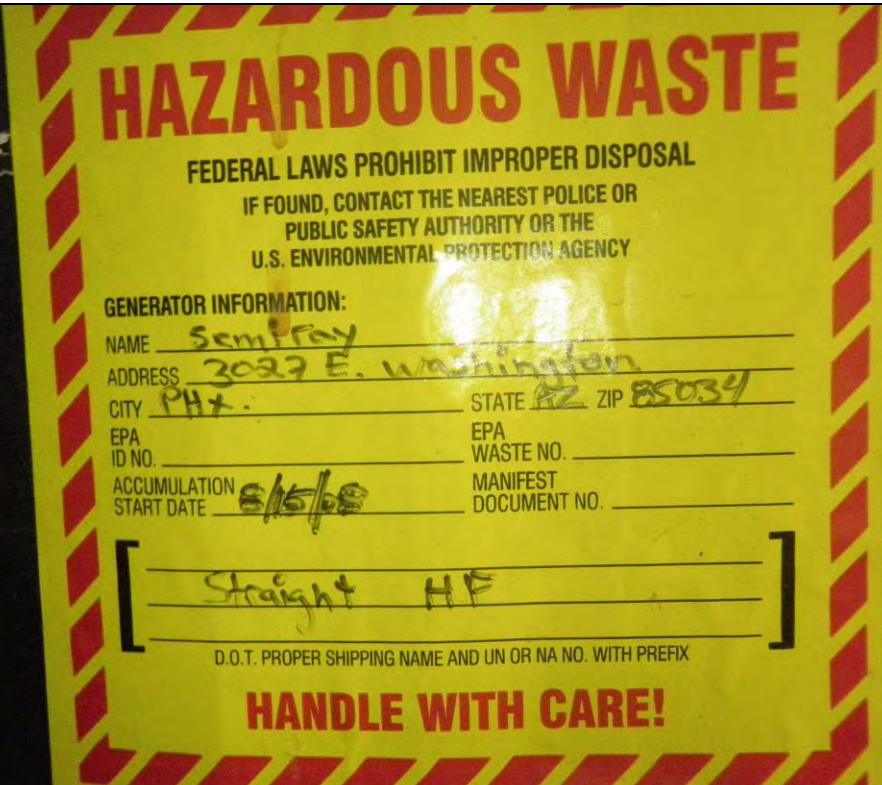
<b>Photo No.</b> 8	<b>Date:</b> 2/1/10
<b>Direction Photo Taken:</b> Close Up	
<b>Photo Description:</b>  180-Day Hazardous Waste Storage Area:  One 55-gallon container marked "Hazardous Waste Straight HF." The container was closed and was properly marked, but was generated more than 180 days from the date of the inspection.

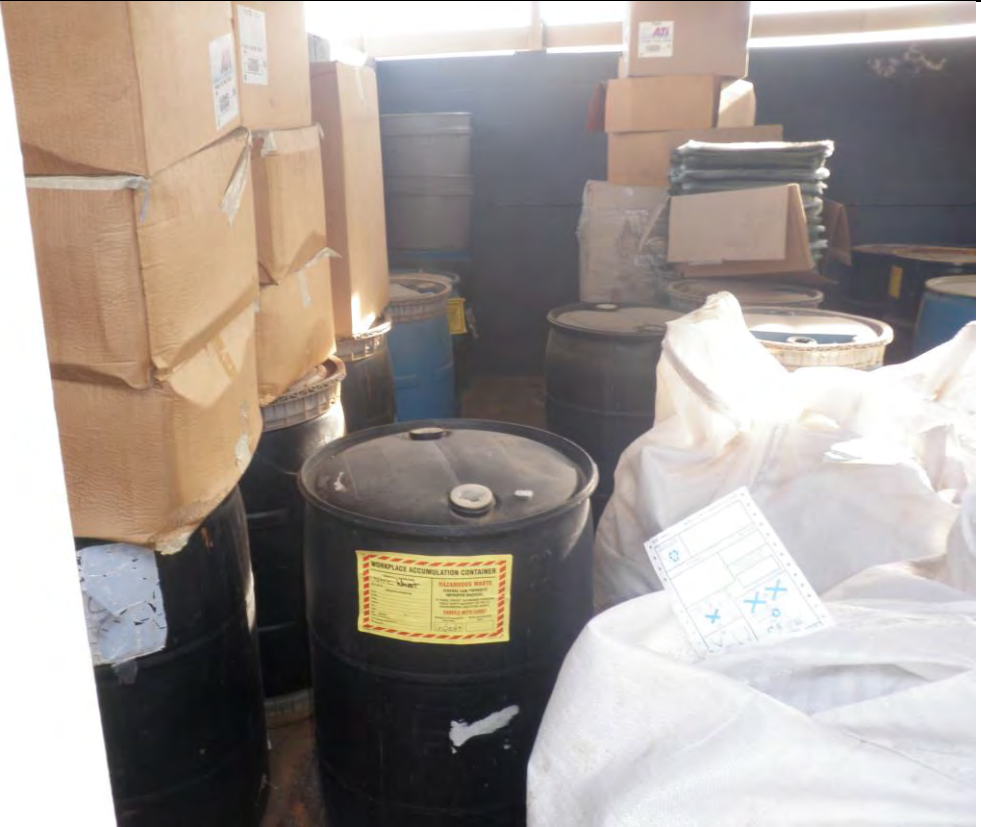
<b>Photographer:</b> Aleksandra Argals		 
<b>Photo No.</b> 9	<b>Date:</b> 2/1/10	
<b>Direction Photo Taken:</b> North		
<b>Photo Description:</b> 180-Day Hazardous Waste Storage Area:  Three closed 55-gallon hazardous waste containers marked "Hazardous Waste Nickel Acetate" and dated "7/24/09," 193 days from the date of the inspection. The drums were to be treated in the Wastewater Treatment Unit (WWTU). Hazardous waste air filters from the paint booth were uncontained and unmarked.

<b>Photo No.</b> 10	<b>Date:</b> 2/1/10	 
<b>Direction Photo Taken:</b> North		
<b>Photo Description:</b> 180-Day Hazardous Waste Storage Area:  Two containers of F006 waste from Photographs #3-4 were properly marked, dated, and closed during the inspection.

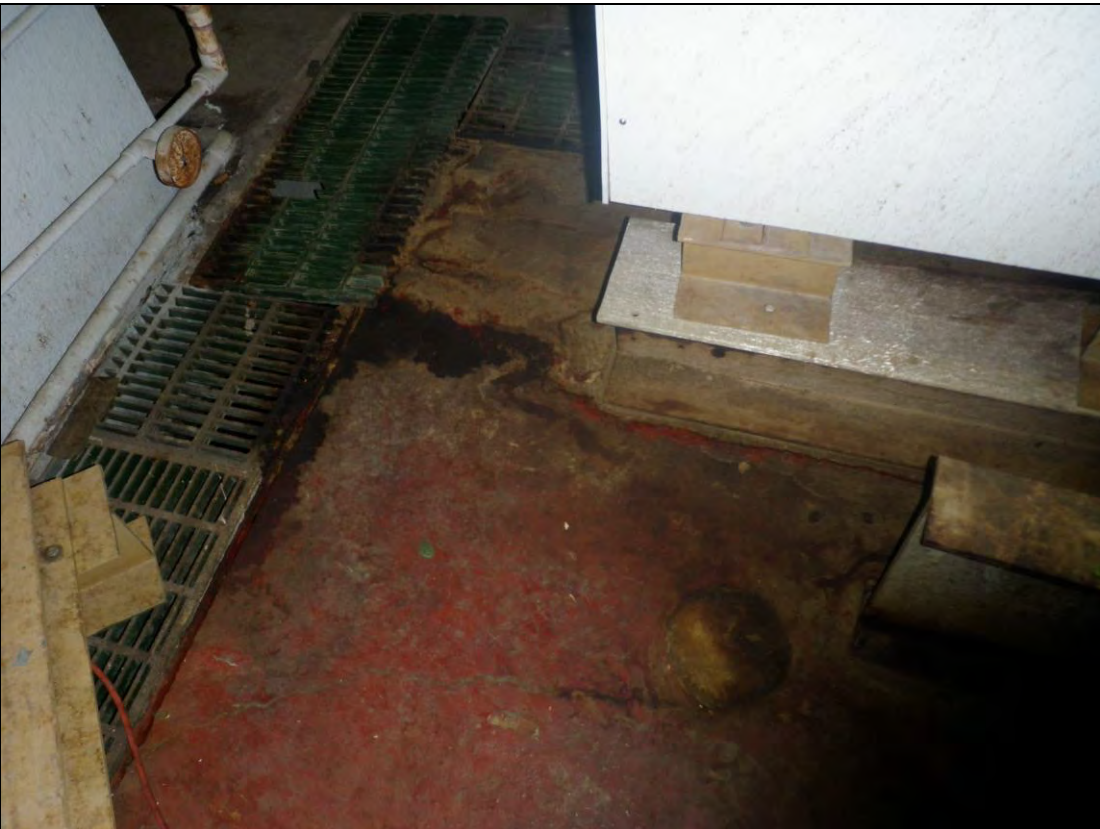
<b>Photo No.</b> 39	<b>Date:</b> 2/1/10	
<b>Direction Photo Taken:</b> Down		
<b>Photo Description:</b>  Wet Chemical Processing - Anodizing Line:  Flooring showing evidence of hexavalent chromium release. The hexavalent chromium anodizing bath is located above the upper right corner of the photograph.  Also observed is the location of a recent sampling event conducted as a part of the East Washington Superfund Site investigation.

<b>Photo No.</b> 40	<b>Date:</b> 2/1/10	 
<b>Direction Photo Taken:</b> Down		
<b>Photo Description:</b>  Wet Chemical Processing - Anodizing Line:  Sump showing evidence of hexavalent chromium containment. This location of the sump is cleaned out as needed by facility employees.

ADEQ compliance officers observed the trench in the corner next to the hexavalent chromium tank in the anodizing line, where chromium solution appeared on the floor and in the trench (Photographs #39-42). Facility representatives stated the sump is cleaned out as needed by facility employees.

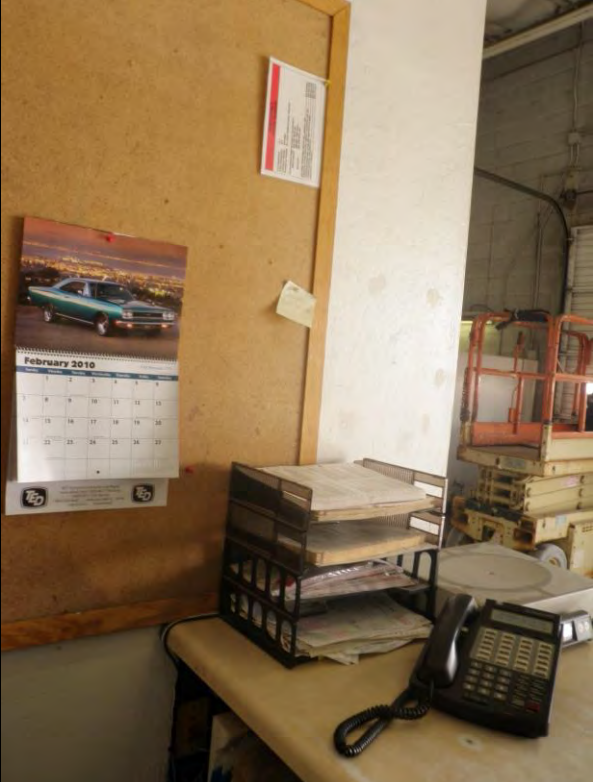
<b>Photo No.</b> 48

<b>Direction Photo Taken:</b> East		
<b>Photo Description:</b>  Shipping and Receiving:  Emergency contact and phone list posted above the telephone. This is the closest phone to the 180-Day Hazardous Waste Storage Area.

ADEQ compliance officers observed an emergency contact and phone list posted above the telephone (Photograph #48). The posted information included the name and phone number of the emergency coordinator and the telephone number of the fire department; however it did not include the location of fire extinguishers or spill control material. This is the closest phone to the 180-Day Hazardous Waste Storage Area.

Semiray had emergency contact information posted in the Shipping and Receiving Area, which is the closest phone to the 180-Day Hazardous Waste Storage Area (Photograph #48). The posted information included the name and phone number of the emergency coordinator and the telephone number of the fire department; however it did not include the location of fire extinguishers or spill control material.

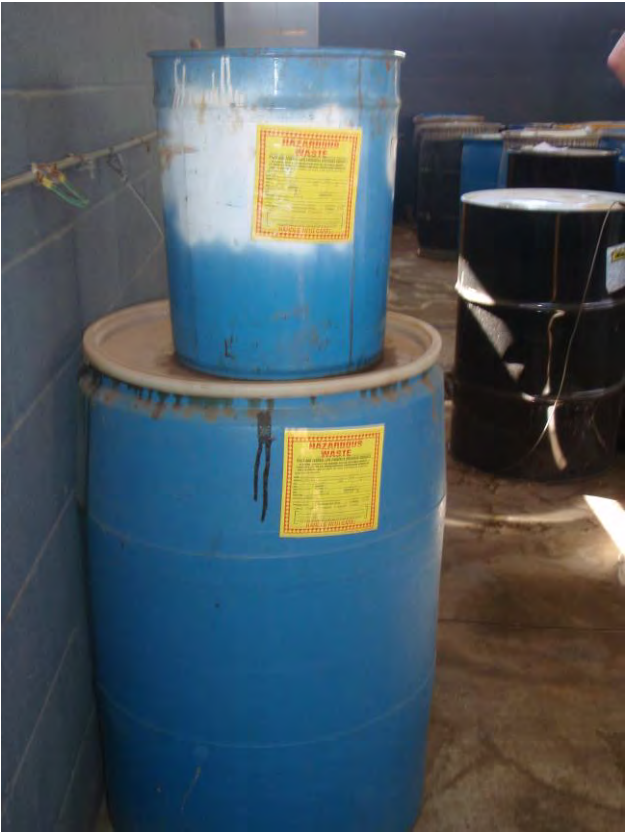
<b>Photo No.</b> 5	<b>Date:</b> 4/19/11	
<b>Direction Photo Taken:</b> South		
<b>Photo Description:</b>  180-Day Hazardous Waste Storage Area:  One 7-gallon container marked as "Chrome Waste" dated "8/22/10;" and one 55-gallon container marked as "Tank Waste" and dated "7/24/10." The containers were closed and properly marked, but were generated more than 180 days from the date of the inspection.

<b>Photo No.</b> 6	<b>Date:</b> 4/19/11	 
<b>Direction Photo Taken:</b> South		
<b>Photo Description:</b>  180-Day Hazardous Waste Storage Area:  One 55-gallon container marked as "Tank Waste" and dated "7/24/10." The container was closed and was properly marked, but was stored longer than 180 days.

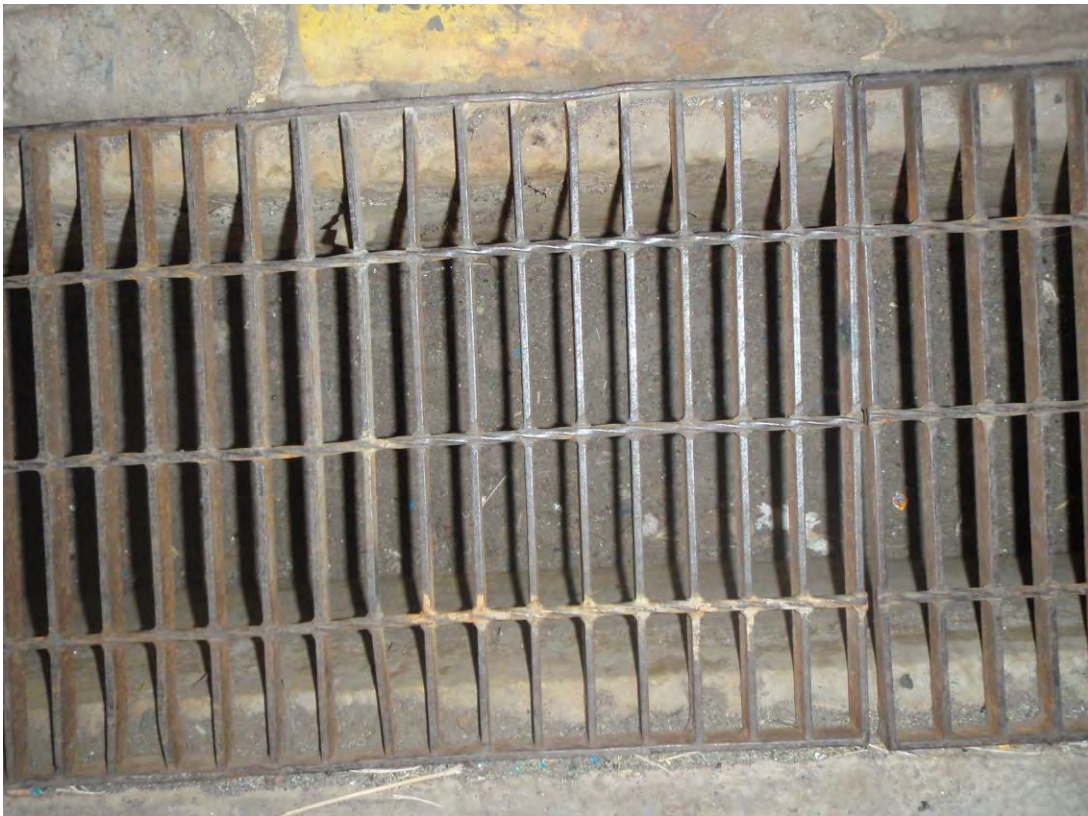
<b>Photo No.</b> 9	<b>Date:</b> 4/19/11	
<b>Direction Photo Taken:</b> Down		
<b>Photo Description:</b>  180-Day Hazardous Waste Storage Area:  The grating was clean, dry, and free of debris. In the hazardous waste inspection, conducted on February 1, 2010, this area was an area of concern.

<b>Photo No.</b> 10	<b>Date:</b> 4/19/11	 
<b>Direction Photo Taken:</b> Southeast		
<b>Photo Description:</b>  180-Day Hazardous Waste Storage Area:  A spill kit, emergency phone numbers, emergency communications system, adequate aisle spacing, emergency shower, eyewash station, and fire extinguishers were observed in the 180-Day Hazardous Waste Storage Area.

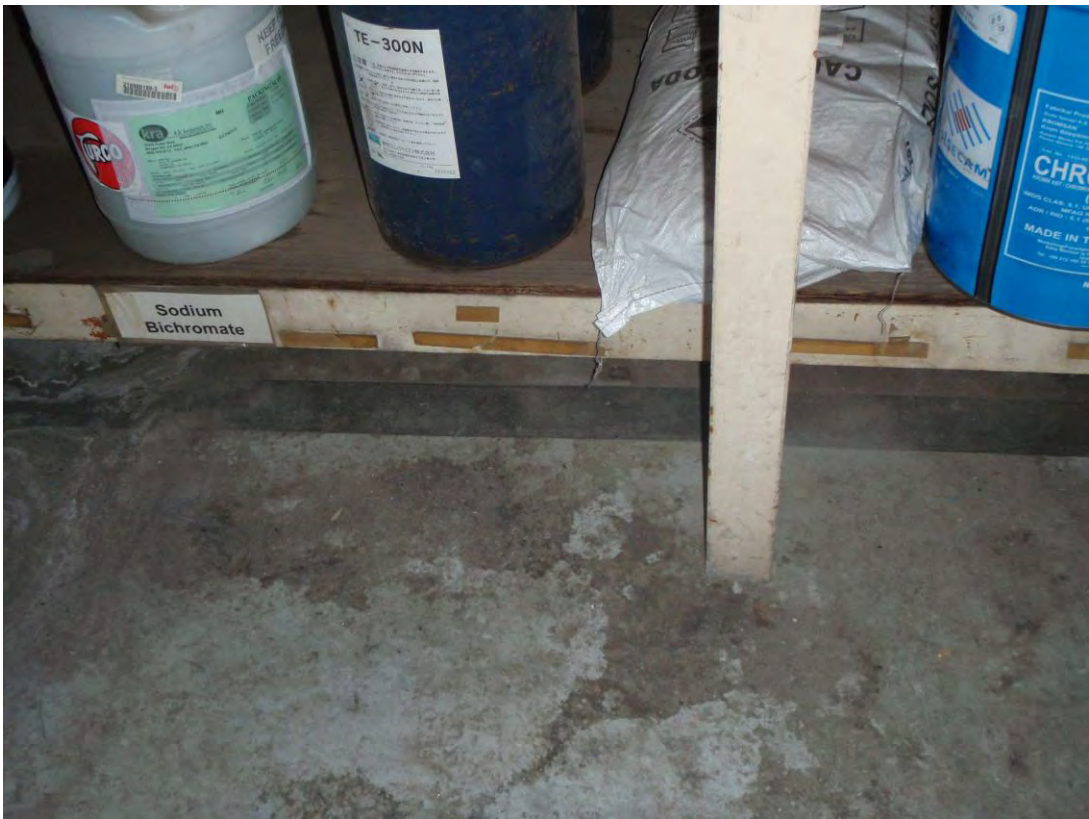
<b>Photographer:</b> Jaclyn Palermo	
<b>Photo No.</b> 11	<b>Date:</b> 4/19/11
<b>Direction Photo Taken:</b> South/Down	
<b>Photo Description:</b>  Materials Storage Area:  Flooring in the Materials Storage Area is clean and free of debris. In the hazardous waste inspection, conducted on February 1, 2010, this area was an area of concern.

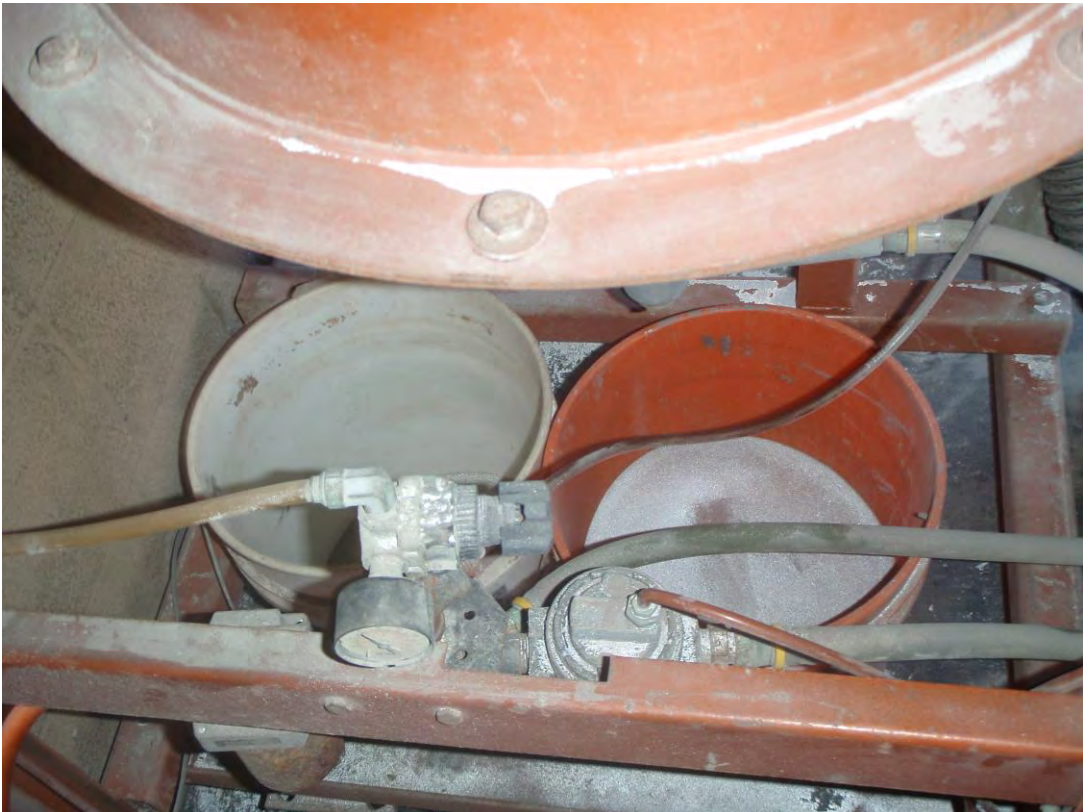
<b>Photographer:</b> Jaclyn Palermo		
<b>Photo No.</b> 13	<b>Date:</b> 4/19/11	
<b>Direction Photo Taken:</b> Down		
<b>Photo Description:</b>  Outside Storage Area:  Two 5-gallon container of sandblast media located under the sandblast machine. In the hazardous waste inspection, conducted on February 1, 2010, this area was noted as an area of concern; however, the observed material was a product and not a waste.

<b>Photo No.</b> 14	<b>Date:</b> 4/19/11	 
<b>Direction Photo Taken:</b> South		
<b>Photo Description:</b>  Wastewater Treatment Area:  One closed and marked as "Hazardous Waste" Super Sack ® (hazardous waste satellite container) tote with less than 55-gallons of plating sludge.

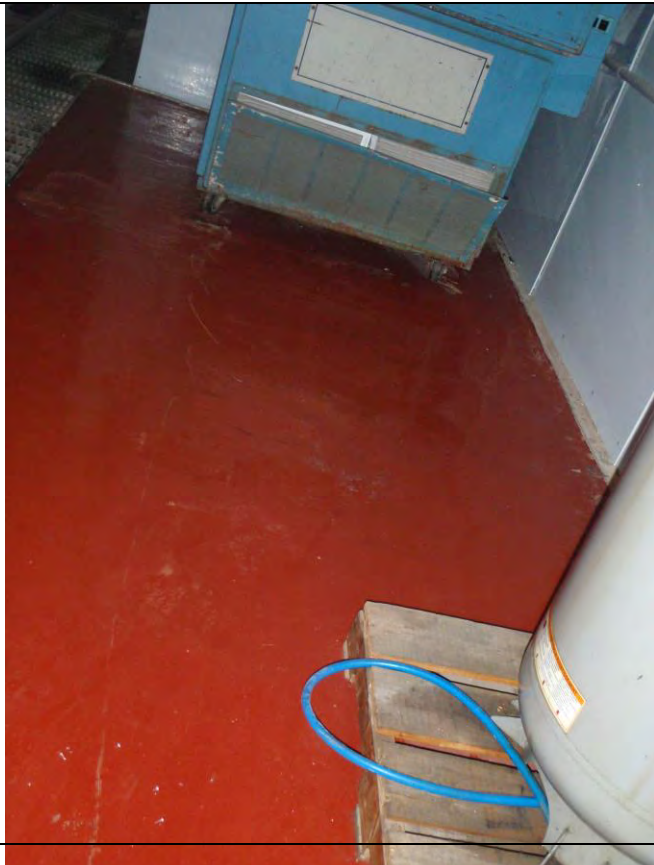
<b>Photo No.</b> 19	
<b>Date:</b> 4/19/11	
<b>Direction Photo Taken:</b> Down	
<b>Photo Description:</b>  Former Chemfilm Line:  In the hazardous waste inspection, conducted on February 1, 2010, this area was noted as an area of concern.  This is the former location of the Chrome Area/ Wet Chem Processing Line.

<b>Photo No.</b> 20	<b>Date:</b> 4/19/11
<b>Direction Photo Taken:</b> Southeast	
<b>Photo Description:</b>  ADEQ compliance officers observed standing liquid on the floor next to the alkaline cleaner tank.  The pH strip indicated the solution had a pH of 10; the solution is not a RCRA hazardous waste.

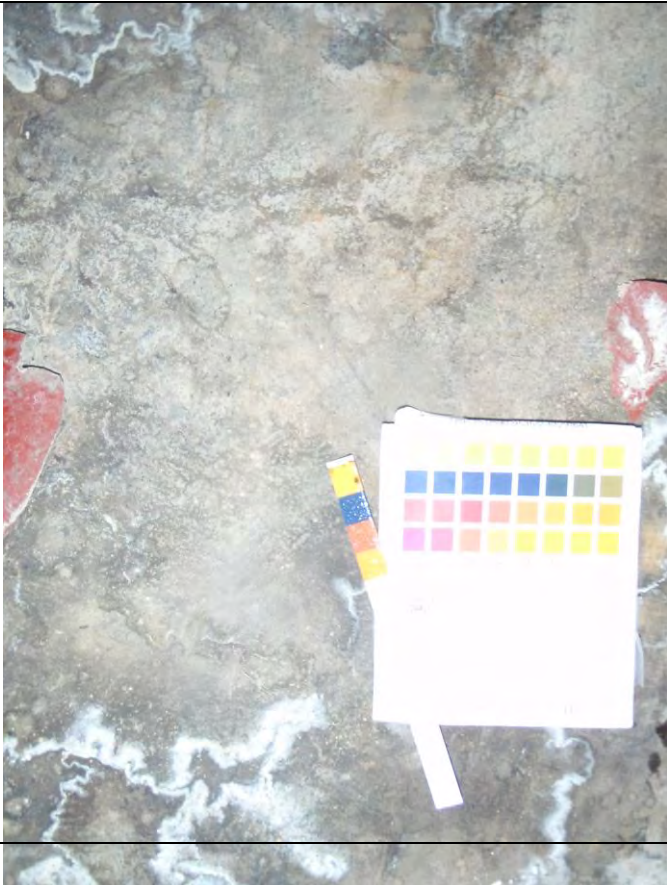
<b>Photo No.</b> 21	<b>Date:</b> 4/19/11	
<b>Direction Photo Taken:</b> Down		
<b>Photo Description:</b>  ADEQ compliance officers observed standing liquid on the floor next to the alkalene cleaner tank.  The pH strip indicated the solution had a pH of 10; the solution is not a RCRA hazardous waste.

<b>Photo No.</b> 22	<b>Date:</b> 4/19/11
<b>Direction Photo Taken:</b> Down	
<b>Photo Description:</b>  Wet Chemical Process Anodizing Line:  An area of the sump, which is connected to the Wastewater Treatment Unit.  In the hazardous waste inspection, conducted on February 1, 2010, this area was noted as an area of concern.
